# Manhole Inspection Summary

Manhole # S350\_\_022MH

Insp Date: **3/19/08 8:29 AM**

**Location** Address: **129 warren**

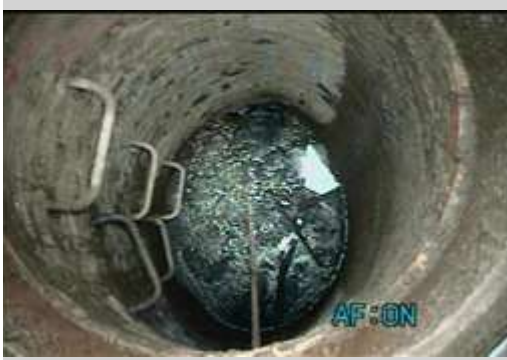
Defect 2

Condition: ☐ Sound ☐ Cracked ☐ Root Intrusion ☐ Deteriorated ☐ Leaks ☒ **Debris**

debris

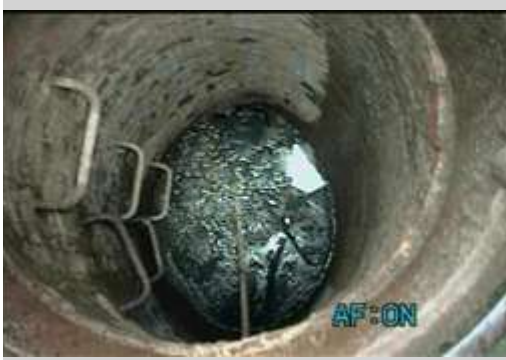
Defect 1

**Steps** Count: **5** Missing: **0** ☒ **Corroded**

steps

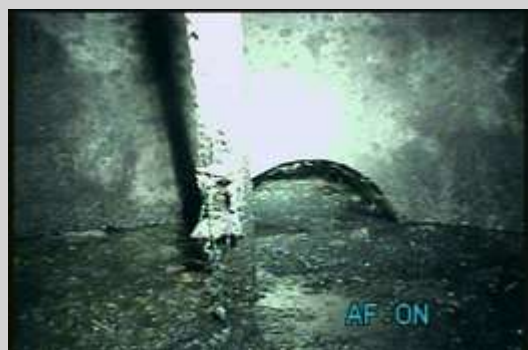
12 O'Clock Outflow

8 in. Circular Gravity Sewer  
Pipe Out @ 12 O'Clock

Deposits: ☐ None ☐ Mud ☒ **Sludge** ☐ Debris ☐ Grease

Silt Depth: **6** (in.) Deposits Extent: **Heavy**
